SMITHSONIAN CONTRIBUTIONS TO MUSEUM CONSERVATION • NUMBER 6

# Conservation of the Exterior of the National Museum of the American Indian Building

*Edited by*  
*Jane Sledge, A. Elena Charola,*  
*Paula T. DePriest, and Robert J. Koestler*

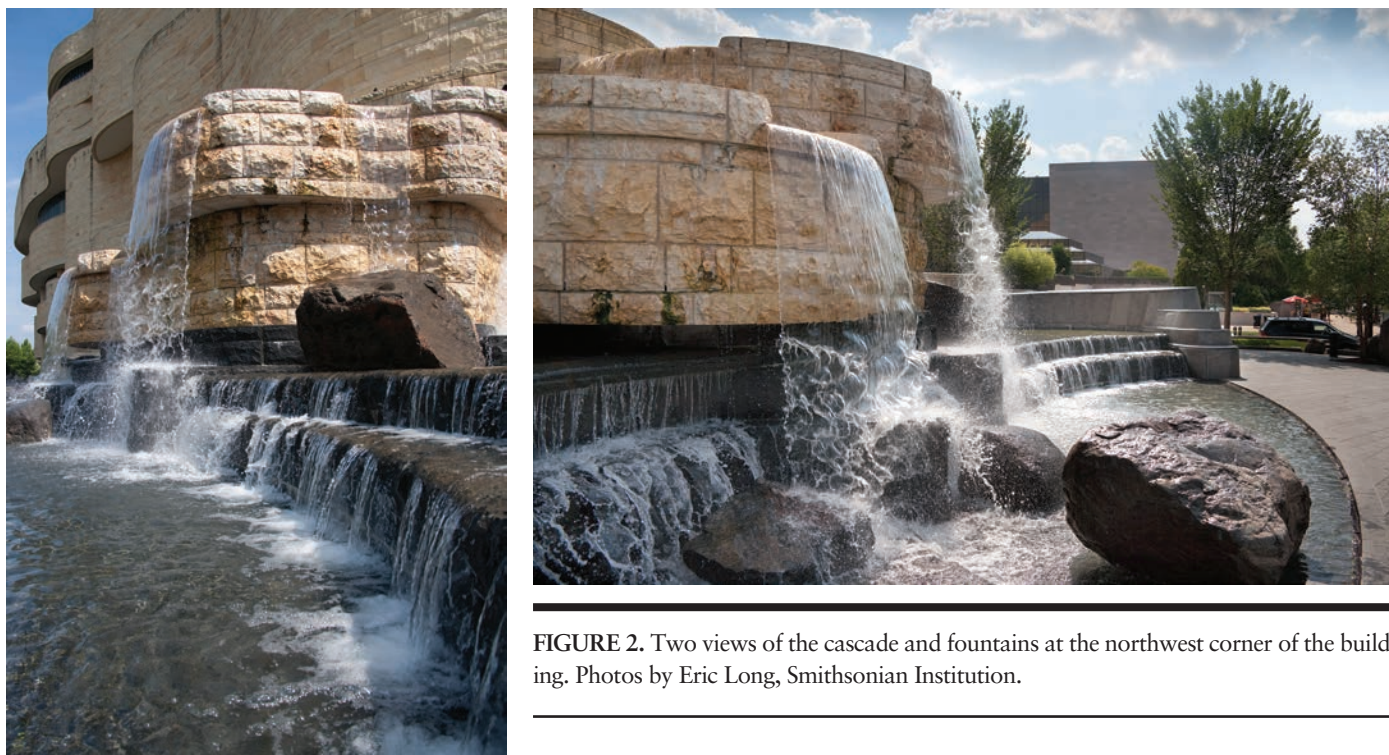
FIGURE 2. Two views of the cascade and fountains at the northwest corner of the building. Photos by Eric Long, Smithsonian Institution.

In addition to the Kasota limestone installed on the facade, a range of other stones were used throughout the building. The cascade portion of the watercourse is made of Golden Sand limestone imported from Mexico, selected to match the Kasota limestone but more resistant to abrasion by water; this stone was also used at the base of the building where it is in contact with water (Figure 2). Exterior paving and a bench in the Potomac are made of American Mist granite quarried by Rock of Ages in Morgantown, Pennsylvania, and fabricated by Granicor of St. Augustin, Quebec. Thermal-finish Mount Airy granite decorates the curbs of planters along the site's perimeter and exterior stair treads. Thermal-finish Missouri Red granite surrounds the maple floor at the center of the Potomac. A single block of red Seneca sandstone, a local stone used for the facade of the Smithsonian Castle, is at the center of the floor, the "hearth and heart of the building." Polished Cambrian Black is used in the museum store and café, polished Giallo

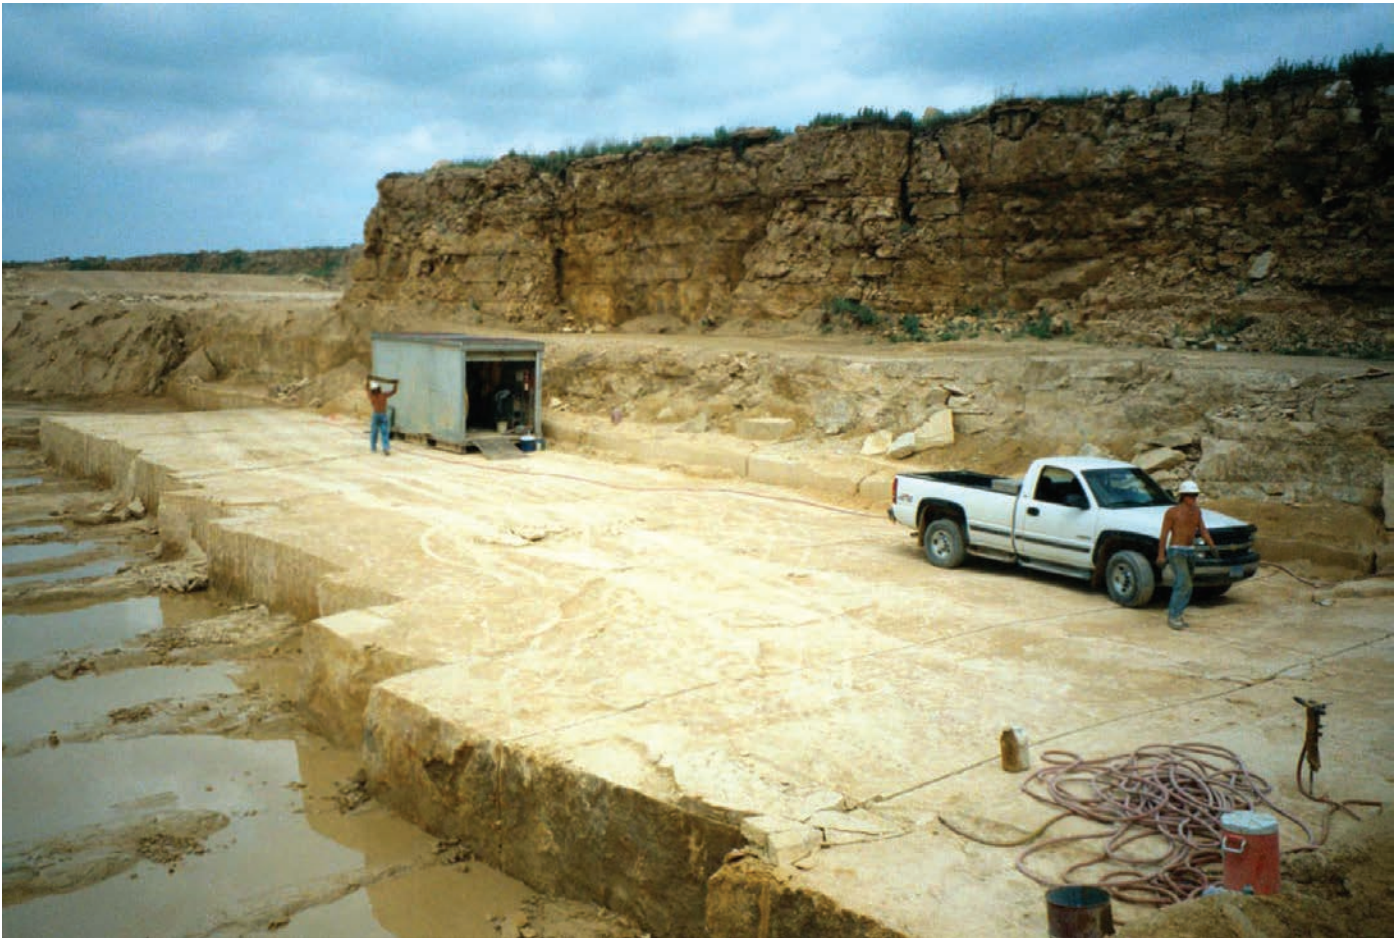
FIGURE 5. A view of the Vetter Stone quarry, Mankato, Minnesota. Photo by Duane Blue Spruce, Smithsonian Institution.

Buff Kasota limestone, technically a dolomitic limestone, was supplied from the more than 200 ha Vetter Stone quarry near Mankato, Minnesota (Figure 5). Instead of using the panelized stone systems common for construction today, 50,000 blocks were custom cut at the quarry with over 150 different curves, both convex and concave (Granitto, 2005).

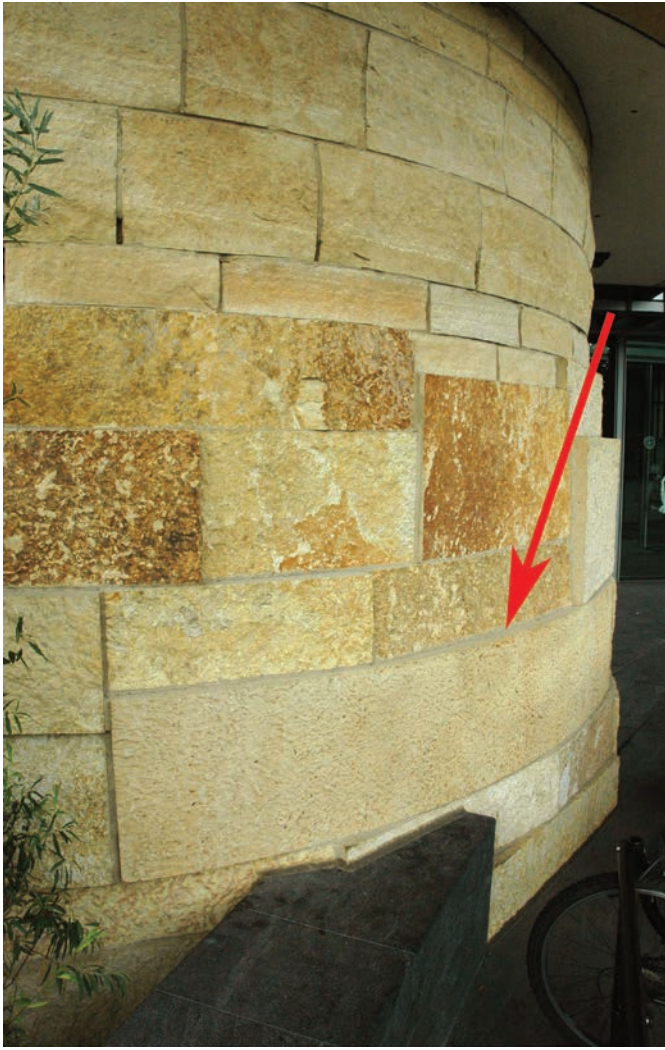
**FIGURE 7.** Area to the left of the building's entrance, showing a nearly 3-m-wide roughback block in the third course, marked with an arrow, whose curvature follows that of the building. Photo by Carol Grissom, Smithsonian Institution.

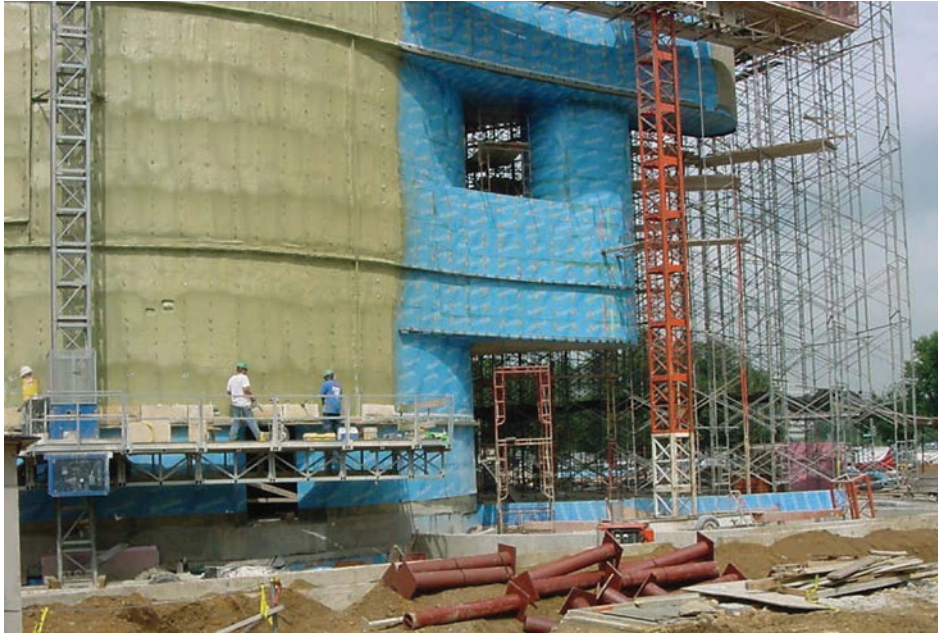
**FIGURE 9.** Installation of splitface blocks at the southeast corner of the building. Note the blueskin moisture barrier, brown polyurethane foam, and shelf brackets at horizontal intervals. Photo by Michael Dobbs, SmithGroup.

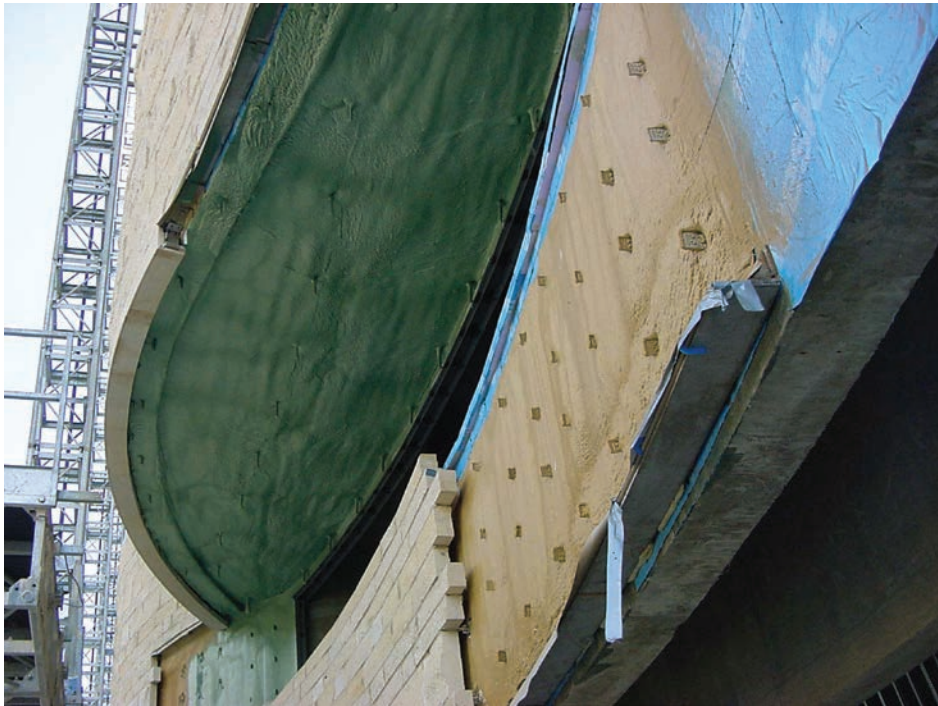
**FIGURE 10.** North wall layers visible during construction: (from interior) concrete structural masonry, blueskin barrier, stainless-steel hardware at intervals with brown foam insulation over top, a 5-cm-wide air gap, and Kasota limestone. A shelf bracket is visible at the base of the brown foam insulated area. Photo by Michael Dobbs, SmithGroup.

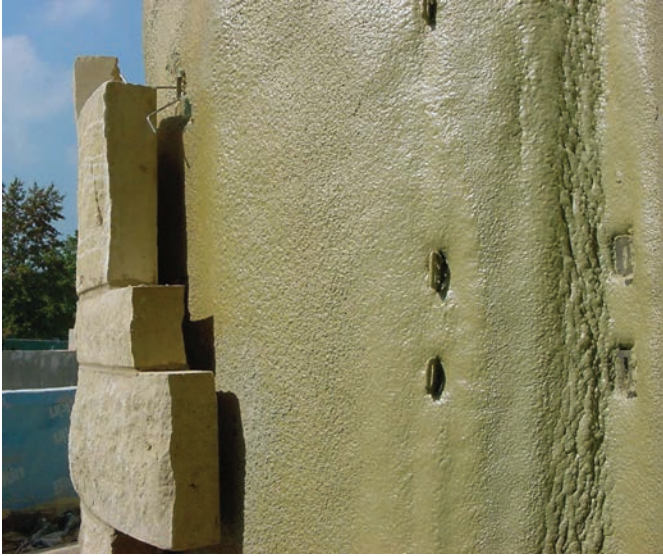
**FIGURE 11.** Detail showing stainless-steel hardware used to attach the Kasota limestone, west facade. Photo by Michael Dobbs, SmithGroup.

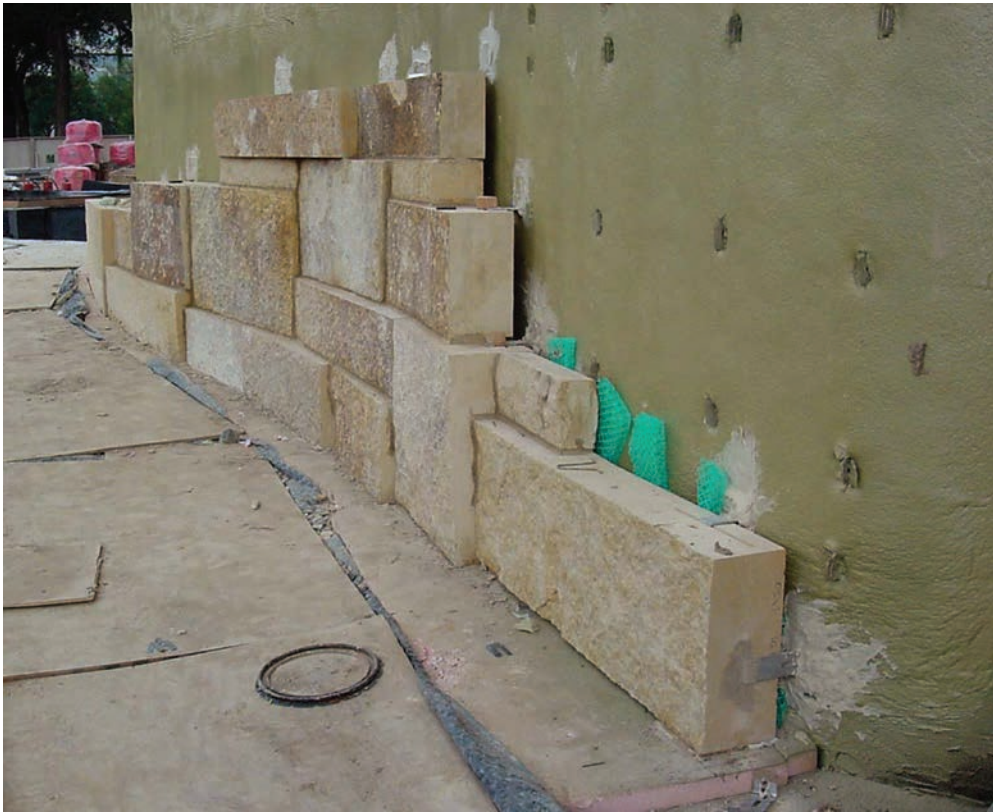
**FIGURE 12.** Blocks of roughback stone at the base of the building during installation. Note the stainless-steel brackets that secure each stone at the sides and on top to the interior structure. Photo by Michael Dobbs, SmithGroup.

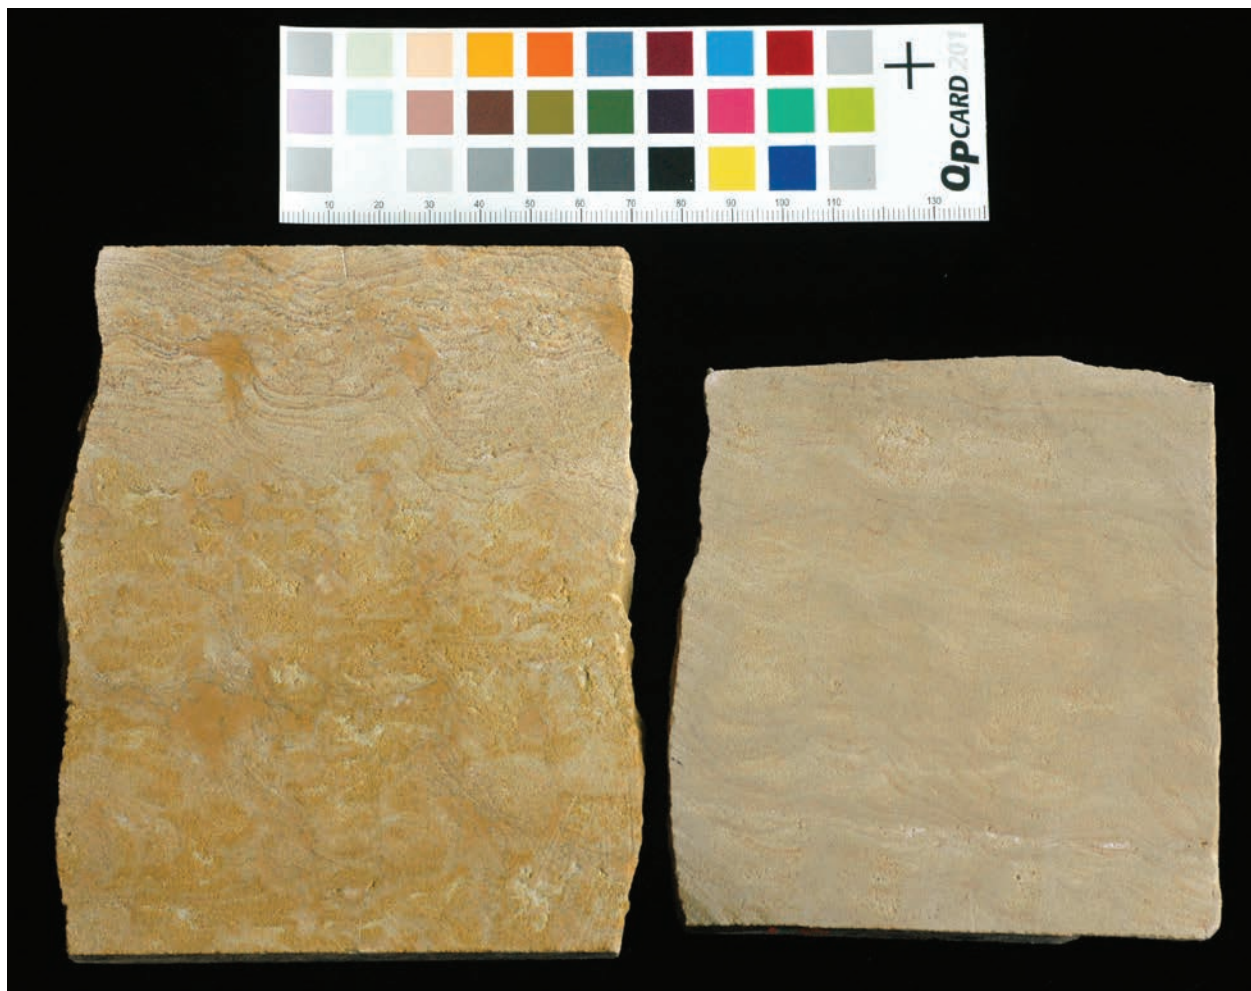
FIGURE 1. Cut surfaces of two wetted blocks of NMAI Kasota limestone showing differences in color and texture. Photo by Carol A. Grissom.

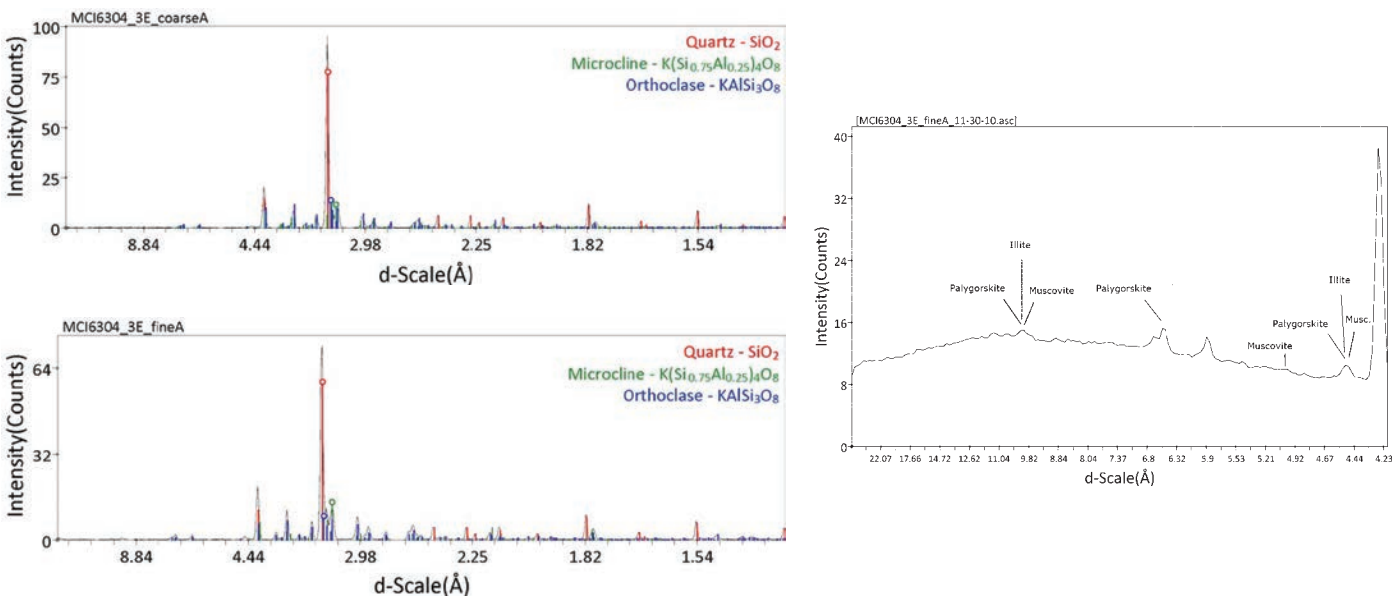
FIGURE 2. The XRD patterns for the acid-insoluble fractions of a NMAI Kasota limestone sample (B) expressed in terms of  $d$  spacing (distance between adjacent lattice planes). Top left: coarse-grain-size fraction. Bottom left: fine-grain-size fraction. Right: detail of the initial section of the pattern for the fine fraction, with peaks associated with mica or clay minerals identified.

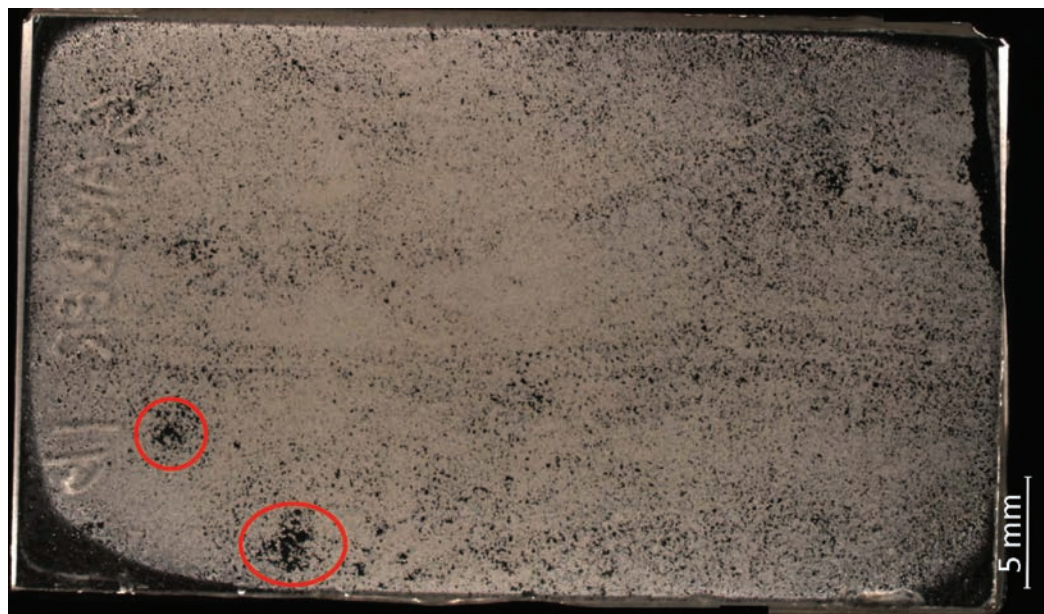
**FIGURE 3.** This dark-field image of an entire thin section of NMAI Kasota limestone (sample 1b) is a mosaic of five image tiles. Pores appear black in this image, and areas with the largest pores are circled in red. The largest pores measure about 1 mm (1,000  $\mu\text{m}$ ) in linear dimension. Composite photo by Melvin J. Wachowiak, Smithsonian Institution.

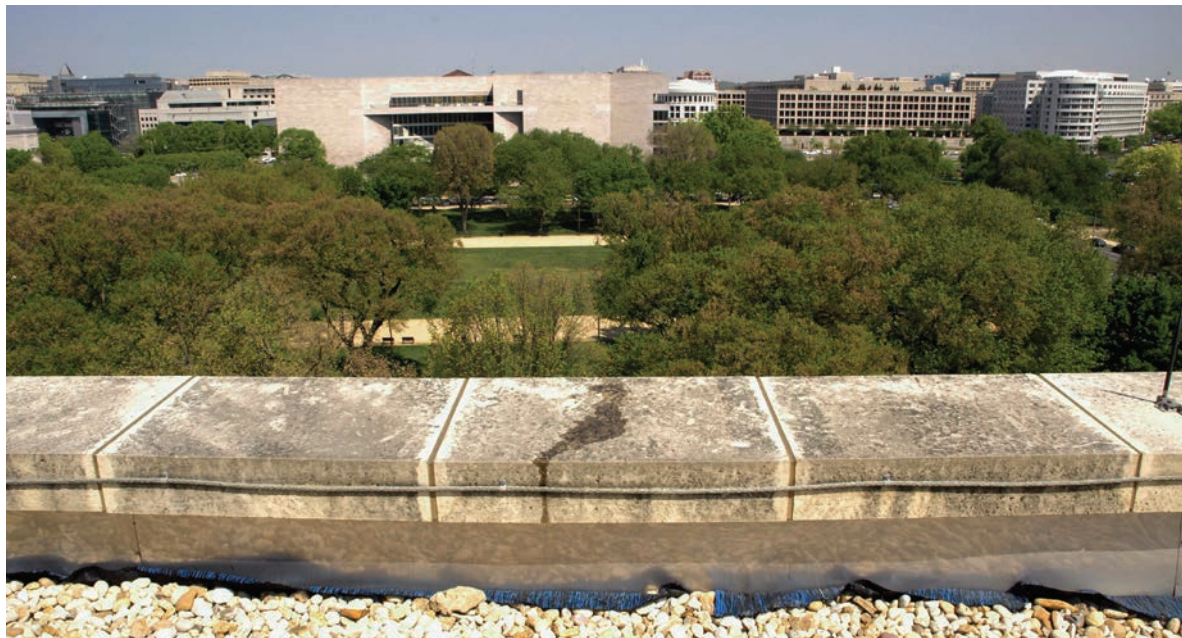
**FIGURE 1.** Darkening of capstones on the roofline (type A) in 2010. Flow of water in both directions when poured onto the center of the middle stone shows that the stone is essentially level. Note the light areas next to joints where water repellent components of silicone sealants bled into the stone. Photo by Carol A. Grissom, Smithsonian Institution.

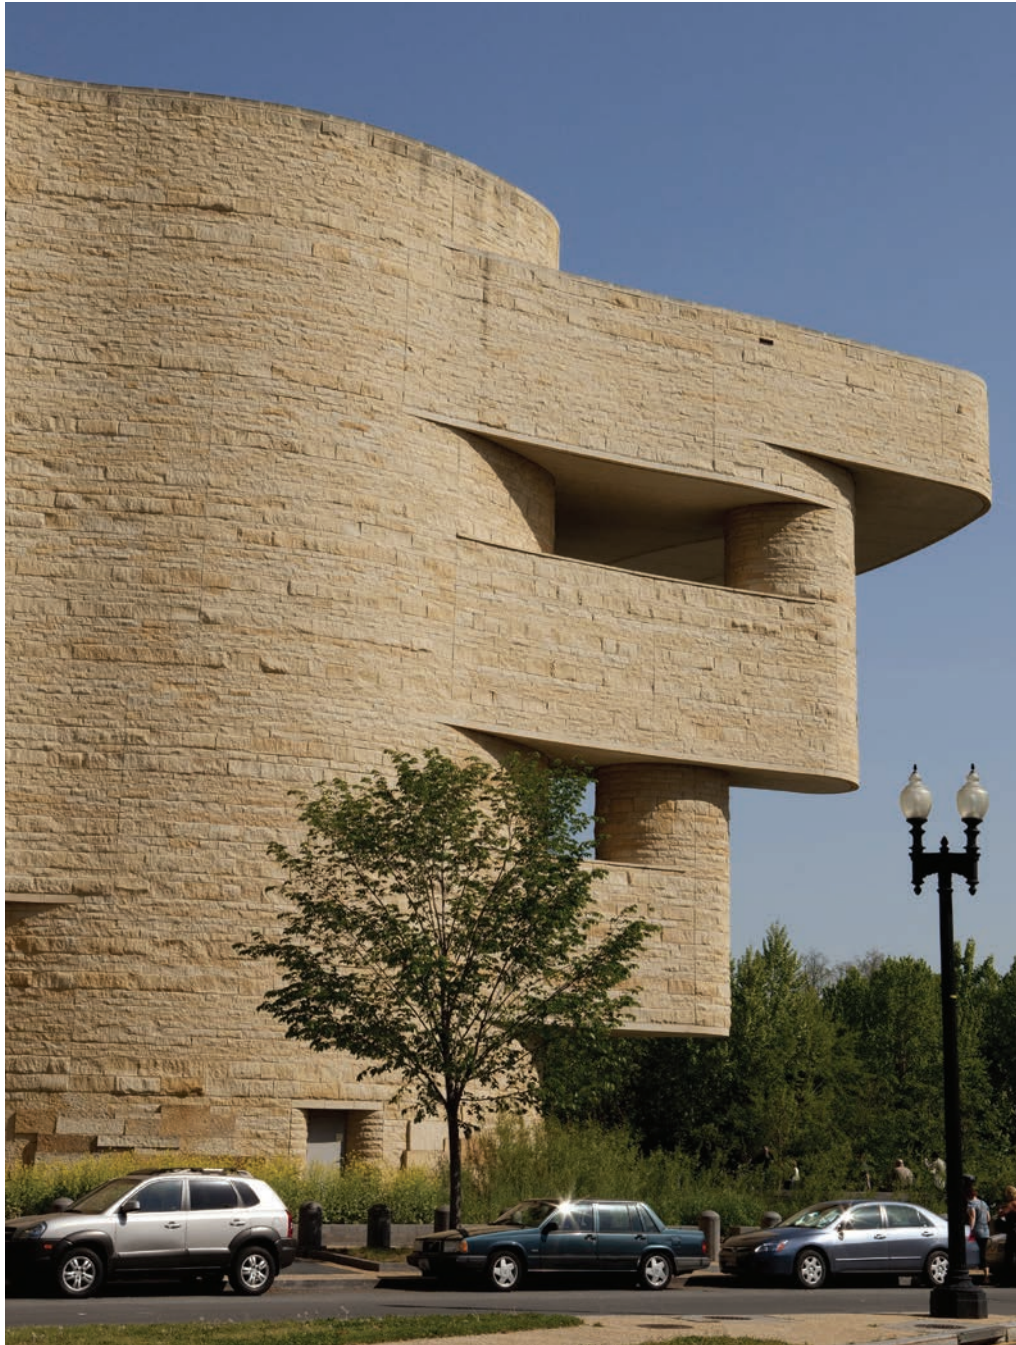
**FIGURE 3.** Slight, relatively uniform darkening (type B) immediately below the roofline of the south facade in contrast to clean-appearing areas below overhangs at right in 2010. Photo by Melvin J. Wachowiak and E. Keats Webb, Smithsonian Institution.

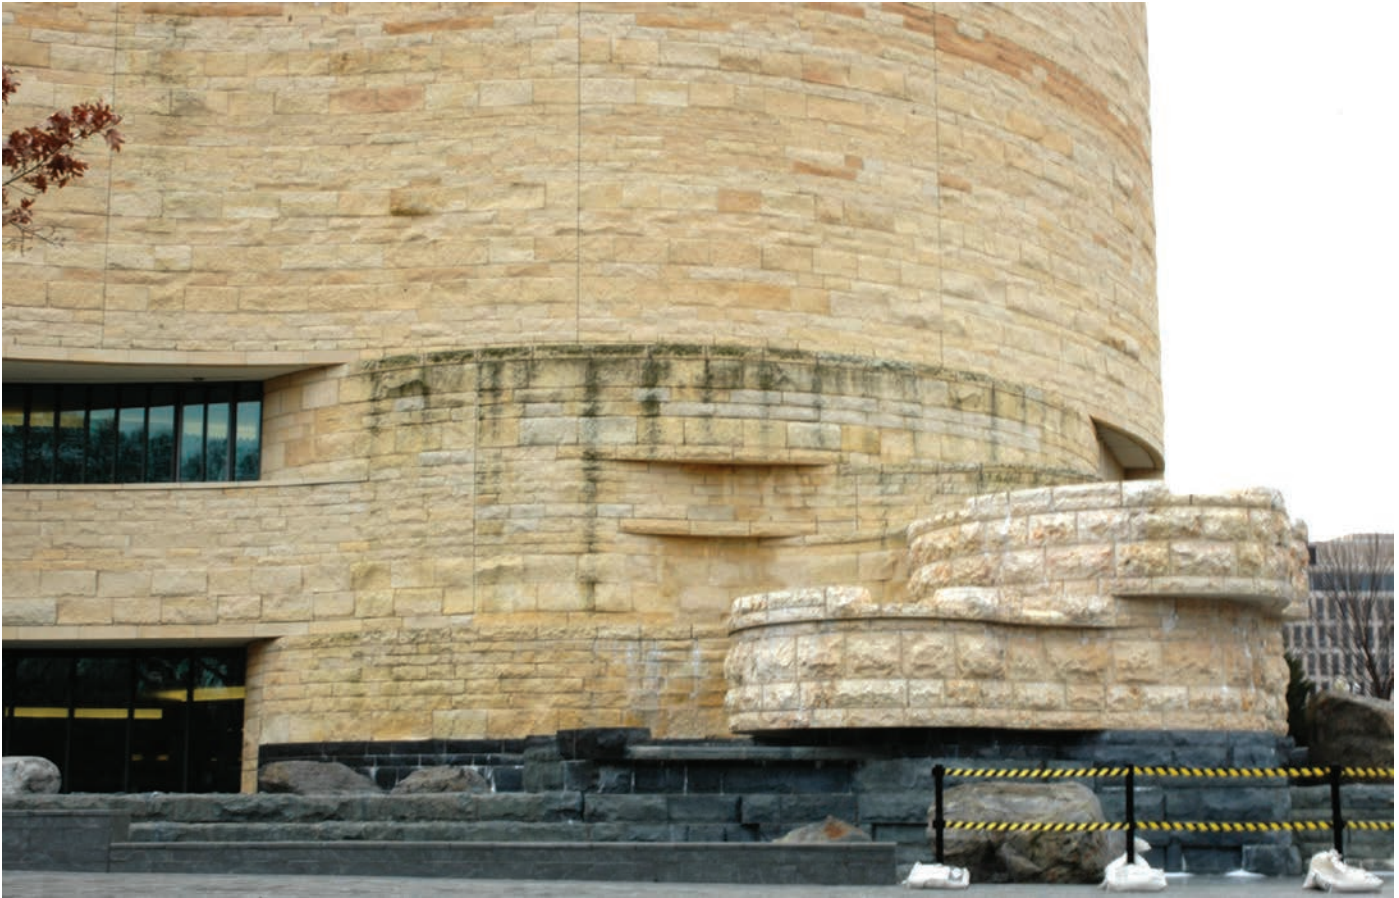
**FIGURE 4.** Prominent dark streaks (type C) below the balcony's capstone joints above the cascade at the northwest corner in contrast to generalized darkening visible on the sides of capstones in 2010. Photo by Carol A. Grissom, Smithsonian Institution.

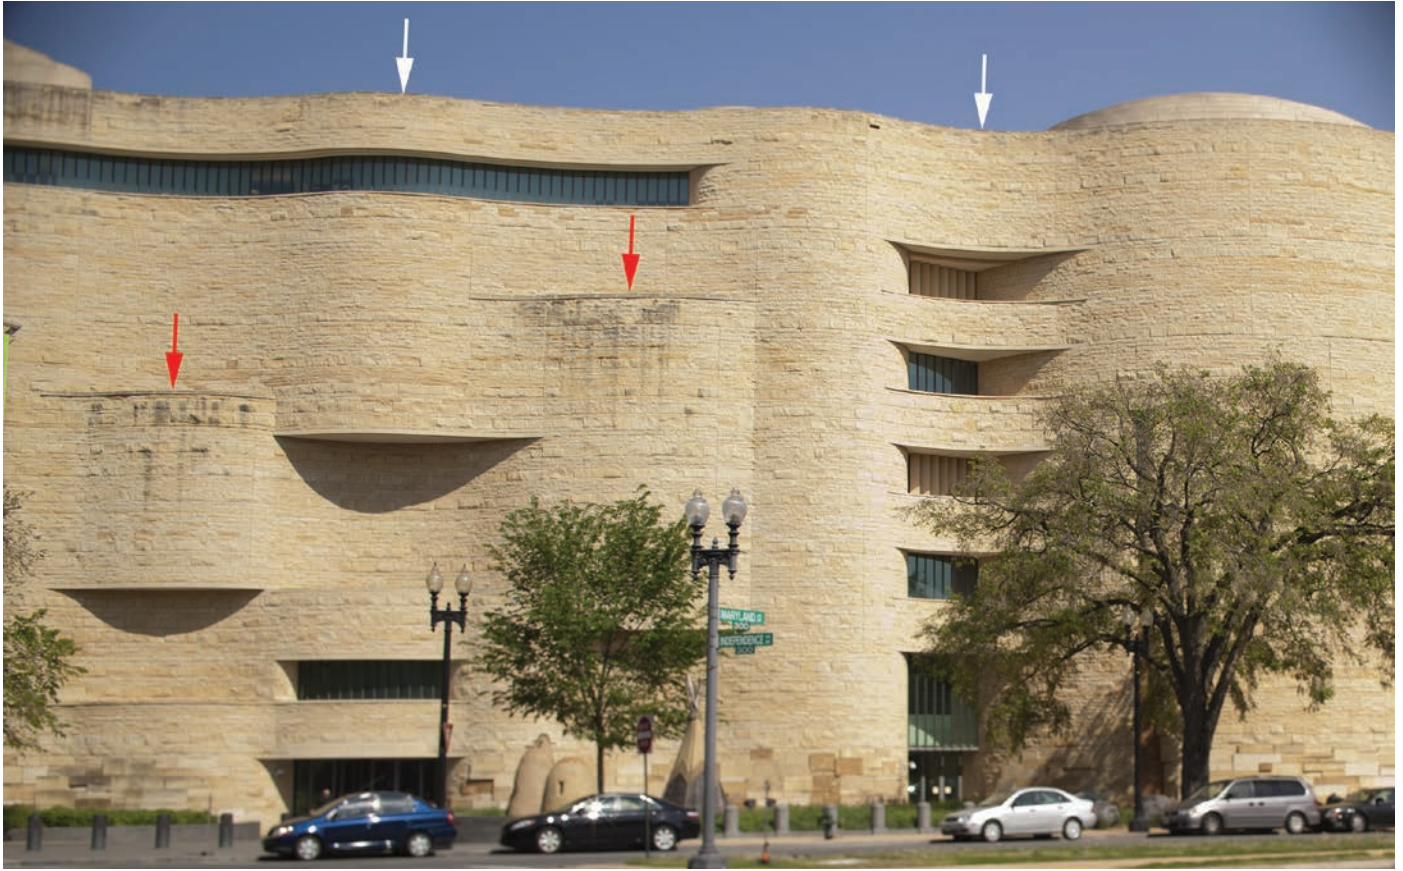
FIGURE 5. Clean-looking stone below balconies protected by overhangs on the south facade (white arrows), in contrast to darkened stone below those that are not protected by overhangs (red arrows), in 2010. Photo by Melvin J. Wachowiak and E. Keats Webb, Smithsonian Institution.

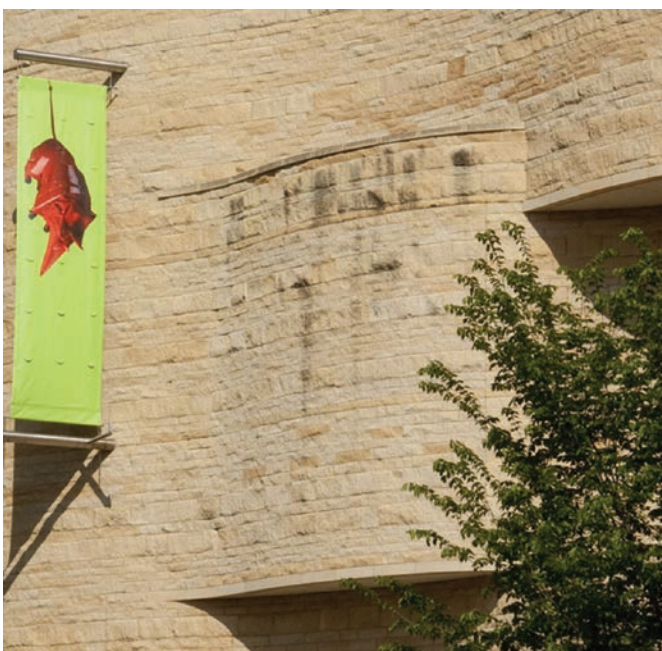
FIGURE 6. Detail of dark streaking (type C) below the unprotected balcony on the left in Figure 5 in 2010. Photo by Melvin J. Wachowiak and E. Keats Webb, Smithsonian Institution.

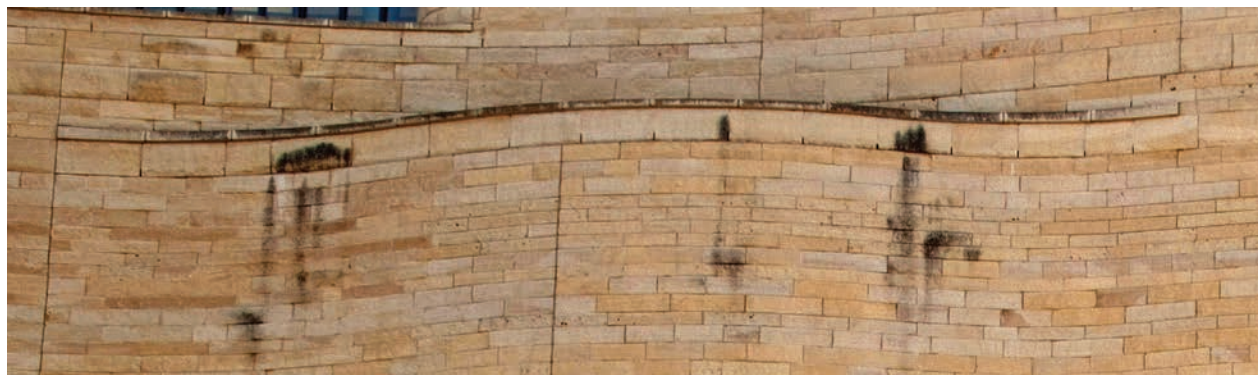
FIGURE 8. Dark streaking below a few capstone joints on west facade balcony 2 in 2010. Photo by Melvin J. Wachowiak and E. Keats Webb, Smithsonian Institution.

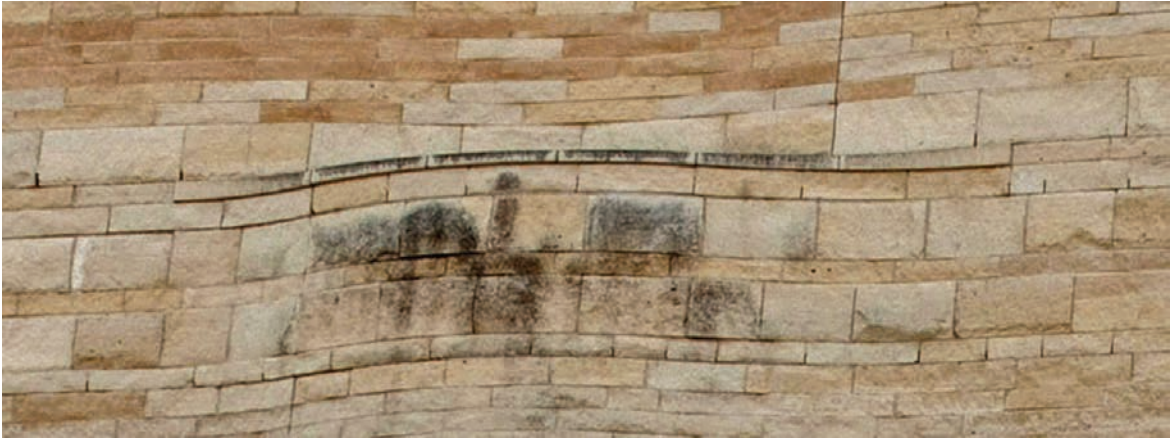
FIGURE 9. Generalized darkening below capstones toward the center of west facade balcony 1, probably from water flowing over the center capstones that are more sloped than those on the sides, in 2010. Photo by Melvin J. Wachowiak and E. Keats Webb, Smithsonian Institution.

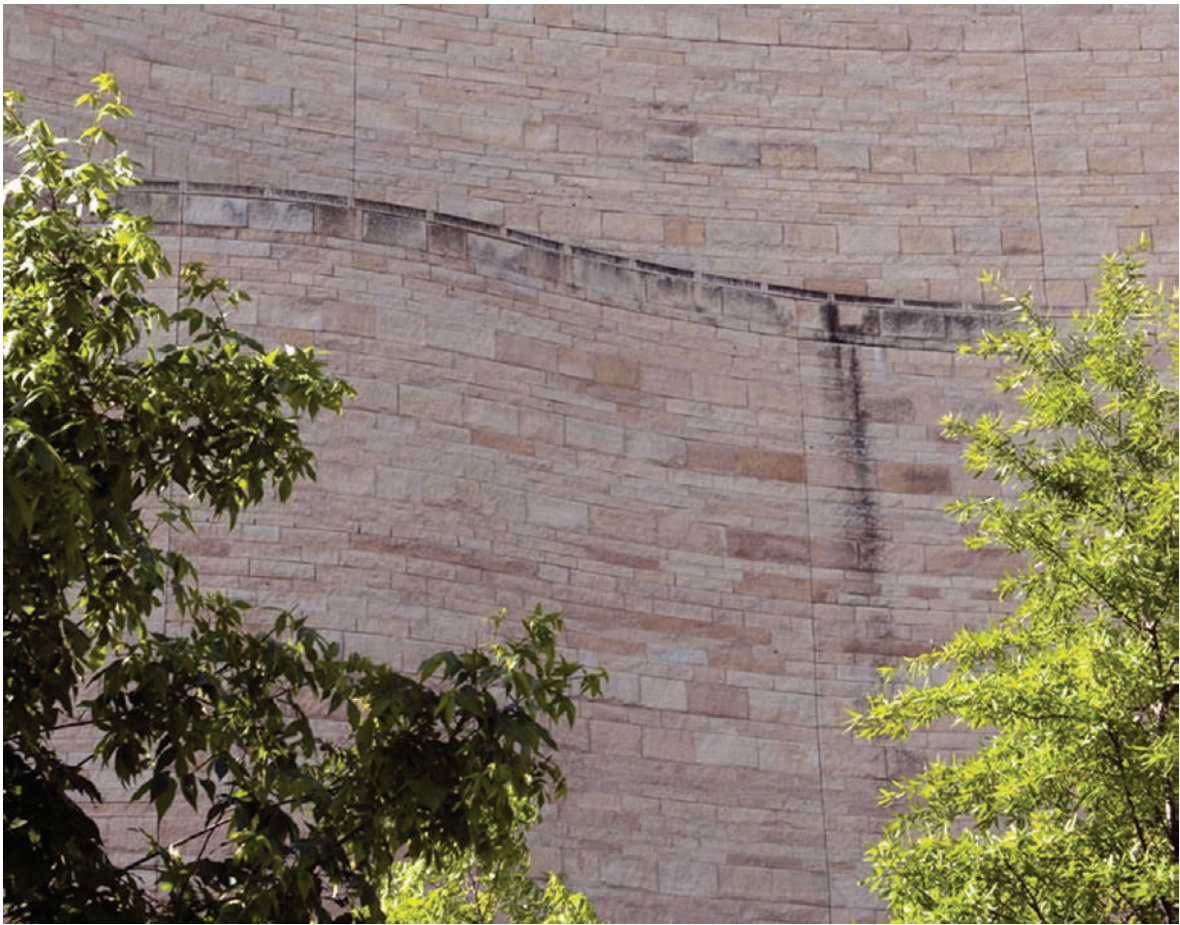
FIGURE 10. Darkening on stonework of the facade below north facade balcony 1, although the capstones slope slightly inward to drains, in 2010. Photo by Melvin J. Wachowiak and E. Keats Webb, Smithsonian Institution.

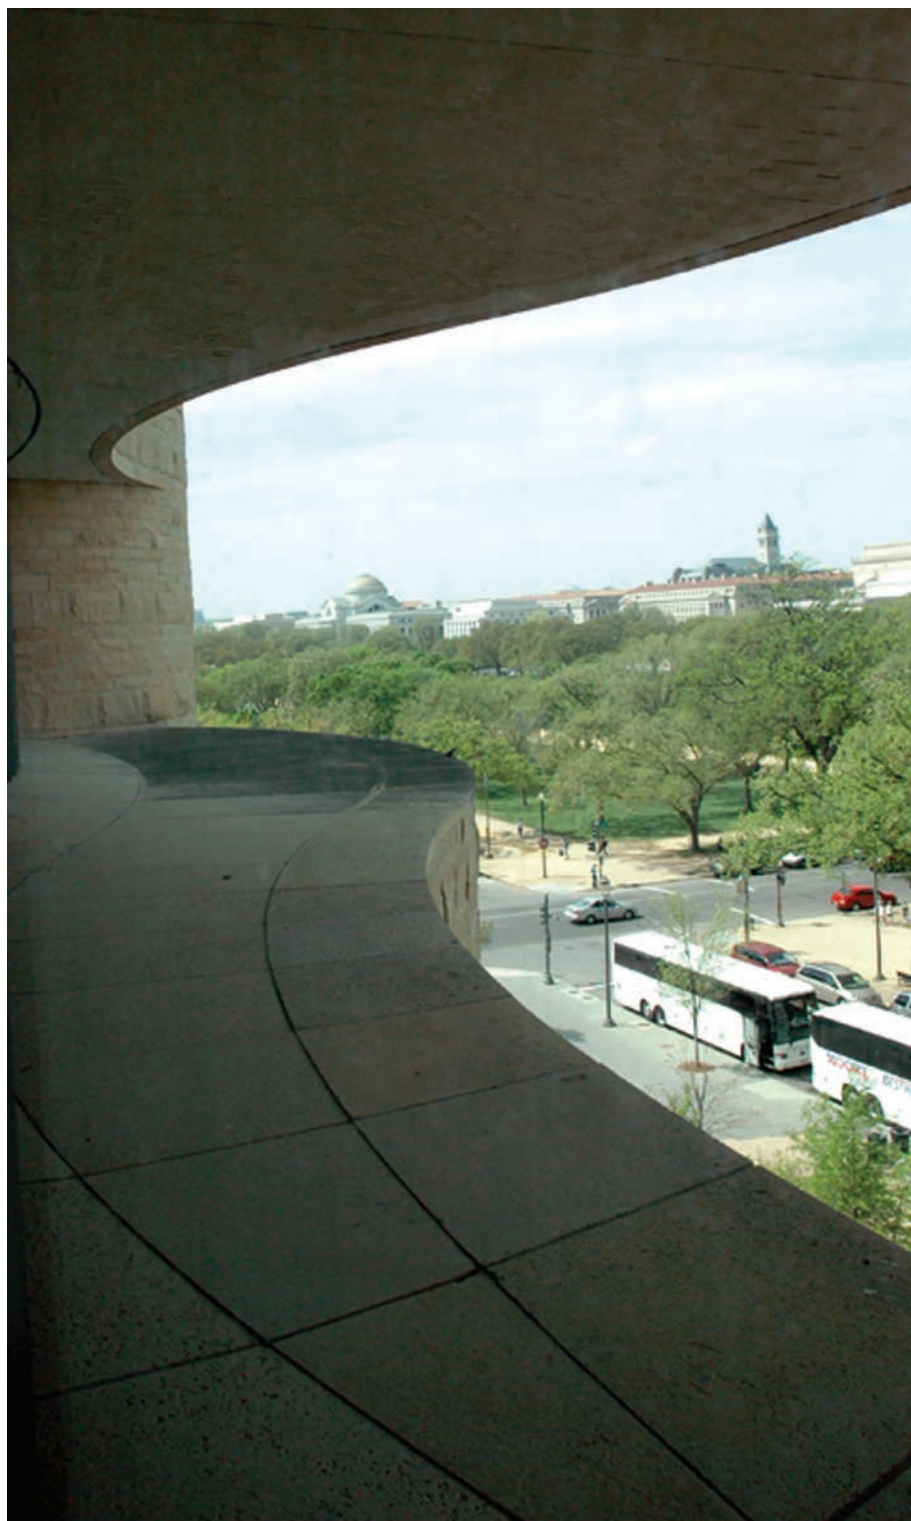
**FIGURE 11.** Dark deposits at the unprotected end of the deck of north facade balcony 2, seen from the fourth floor inside the museum, in 2010. Dark streaks occurred on the facade below, although the outermost stones slope inward on this balcony. Photo by Carol A. Grissom, Smithsonian Institution.

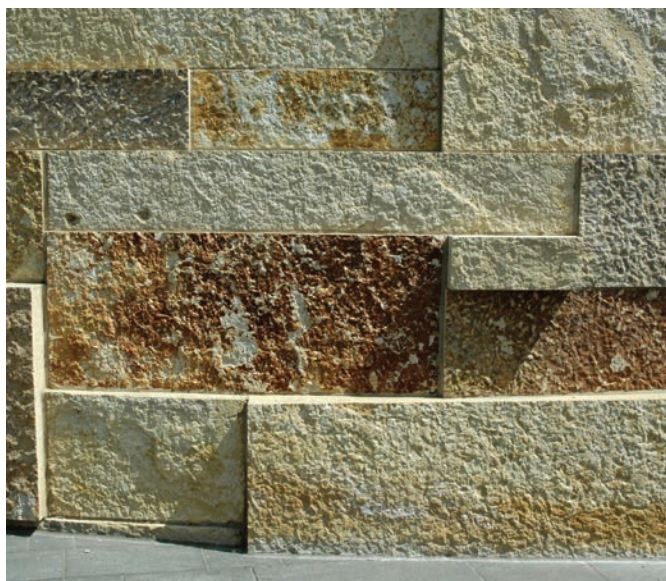
**FIGURE 12.** Slight darkening of some highly colored roughback blocks next to paving in 2010. Photo by Carol A. Grissom, Smithsonian Institution.

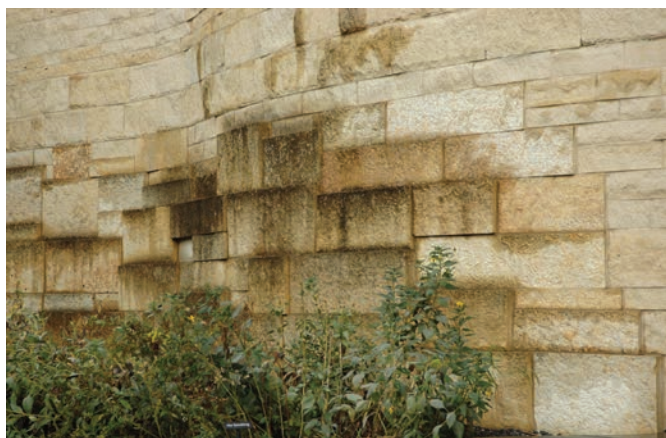
**FIGURE 13.** Wetting and darkening of other roughback blocks (type D) with shielding vegetation nearby, such as these to the left of the Independence Avenue entrance to the building; photographed just after a rain event in 2010. Photo by Carol A. Grissom, Smithsonian Institution.

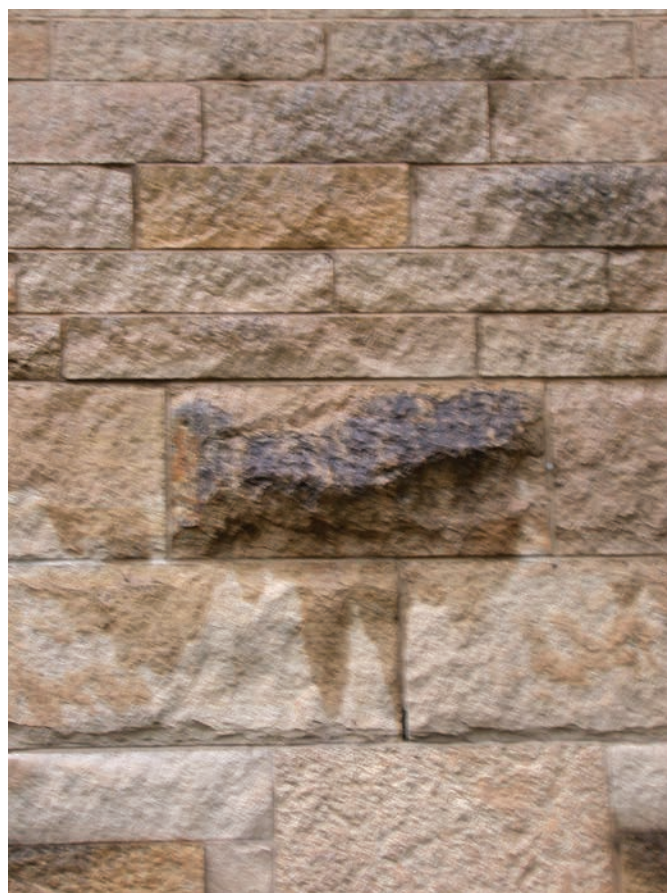
**FIGURE 14.** Wetting and darkening of the protruding block at the center (type D), photographed just after a rain event in 2010. Photo by Carol A. Grissom, Smithsonian Institution.

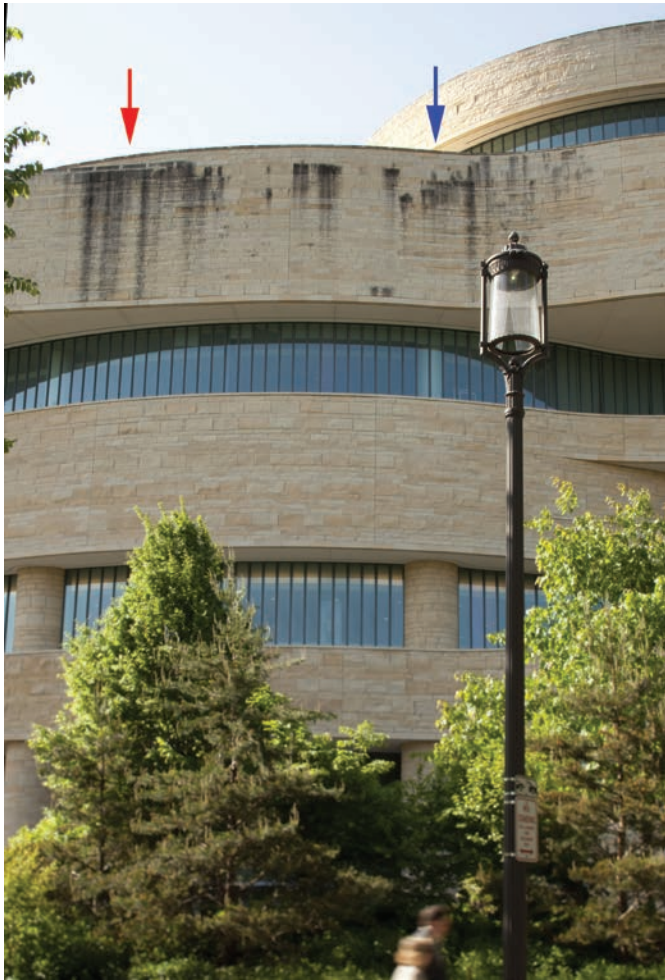
**FIGURE 15.** Dark streaks on the facade (type E) below the Inouye Terrace on the north facade in 2010. The red arrow indicates streaking compounded by runoff from both the terrace and an intersecting parapet wall. The blue arrow indicates streaking by increased runoff from stones sloping toward the intersection of the window sill and parapet wall. Photo by Melvin J. Wachowiak and E. Keats Webb, Smithsonian Institution.

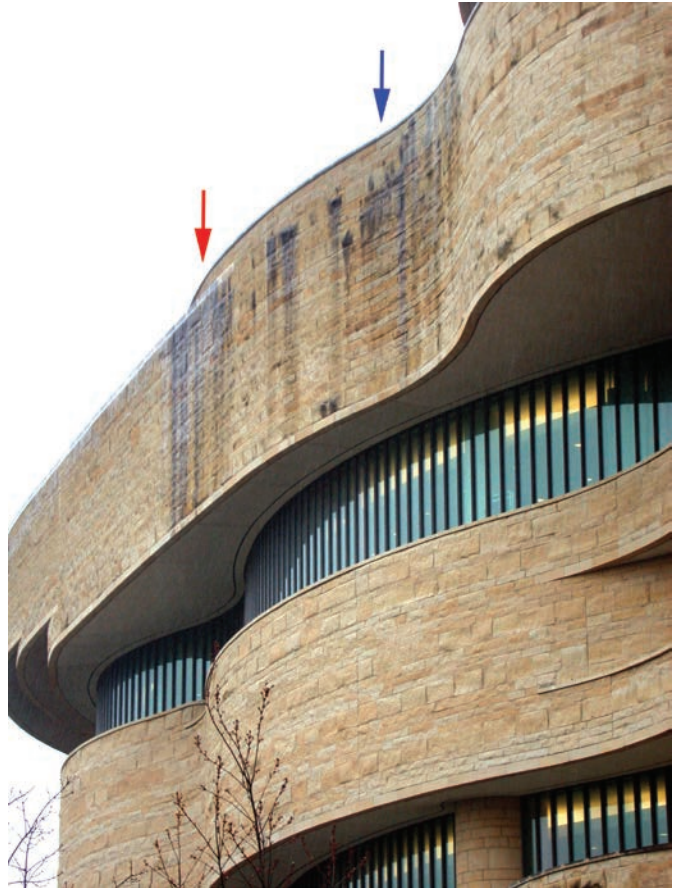
**FIGURE 16.** (Left) Wetting of the area shown in Figure 15, photographed during a rain event in 2010; arrows are as in Figure 15. Photo by Carol A. Grissom, Smithsonian Institution.

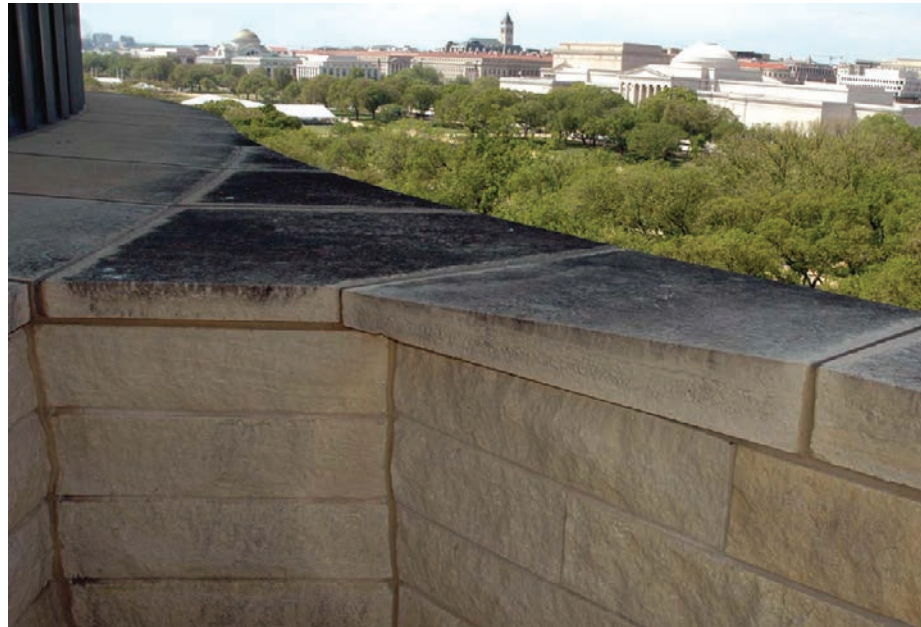
FIGURE 17. Darkening of capstones at the intersection of the Inouye Terrace parapet wall with the windowsill on the left in 2010. The large capstone displaying the darkest surface on the left slopes down and outward, whereas the stone to its right slopes toward it. During rainfall a large volume of water is funneled over these capstones onto the facade, contributing to the severe dark streaks seen in Figures 15 and 16. Photo by Carol A. Grissom, Smithsonian Institution.

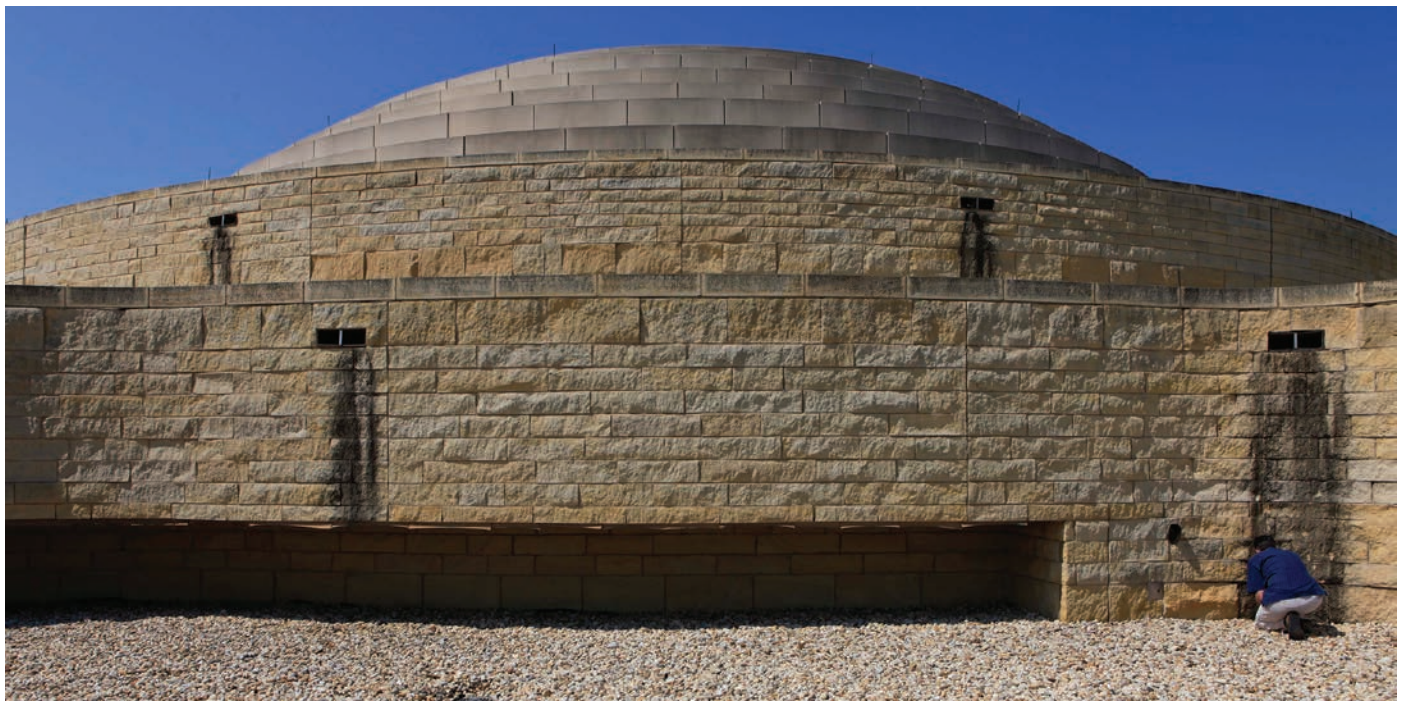
FIGURE 18. Thick, dark deposits under scuppers (type F) that drain roofs atop the NMAI building with flows of large amounts of water in 2010. Photo by E. Keats Webb, Smithsonian Institution.
