SMITHSONIAN CONTRIBUTIONS TO MUSEUM CONSERVATION • NUMBER 6

# Conservation of the Exterior of the National Museum of the American Indian Building

*Edited by*  
*Jane Sledge, A. Elena Charola,*  
*Paula T. DePriest, and Robert J. Koestler*

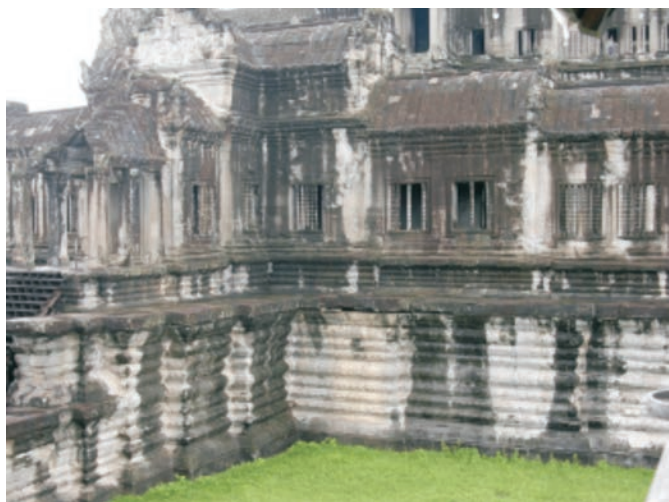
**FIGURE 1.** Characteristic *Tintenstrich* pattern on a structure at Angkor Wat, Cambodia. Note that the pattern follows the water drip lines. Reprinted with permission from Warscheid and Leisen (2011).

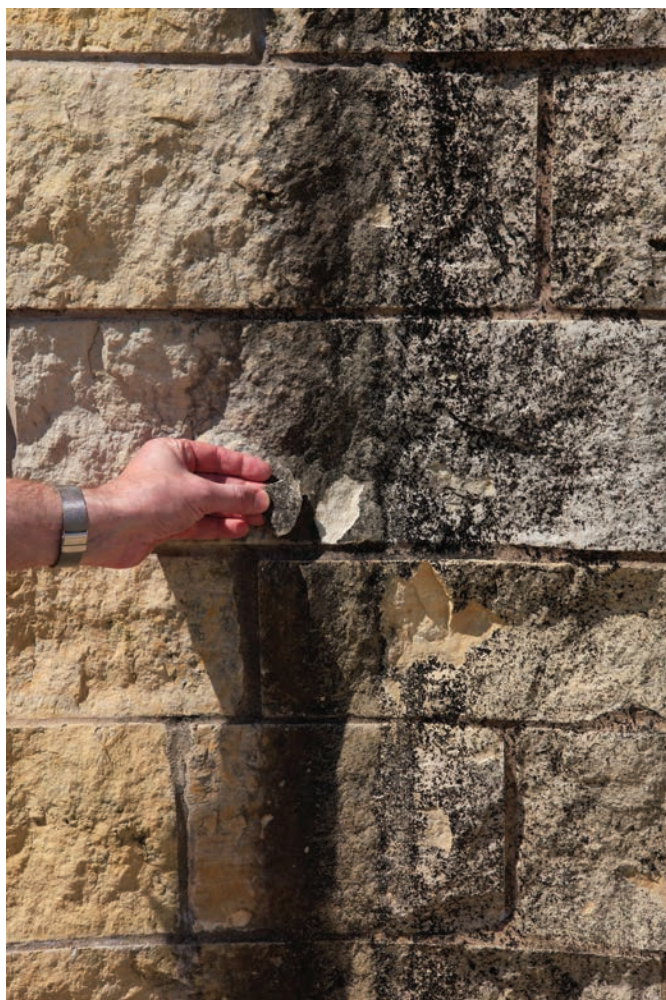
**FIGURE 3.** Exfoliation of the Kasota limestone from the NMAI building in the area below a scupper water drain on the east terrace wall beyond the Senator Inouye Terrace (see figure 18 in Grissom and Charola, “Survey and Documentation of Darkening and Streaking on the National Museum of the American Indian Building,” this volume). The exfoliation or spalling is potentially a result of the blackish epilithic colonization.

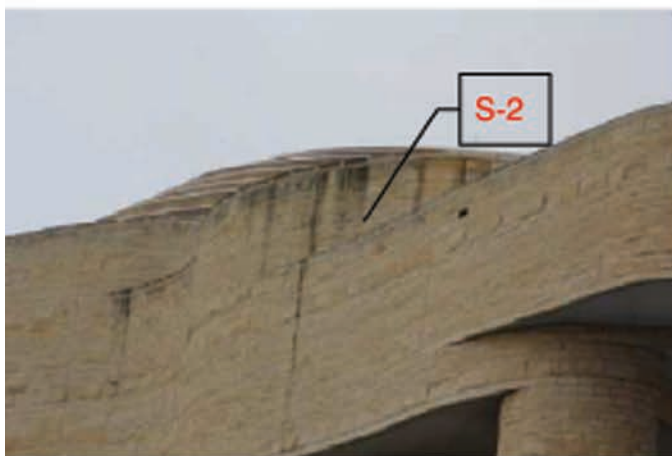
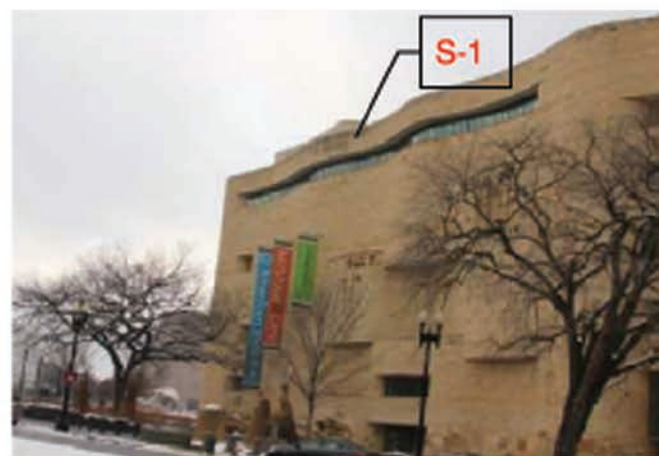
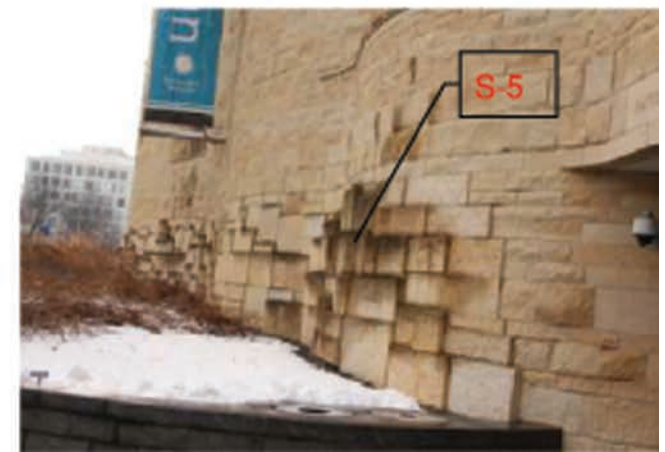
FIGURE 3. Cleaning map for the south facade. Areas S1–S5 to be cleaned are outlined in the top image. Photos by John Bixler, Smithsonian Institution.

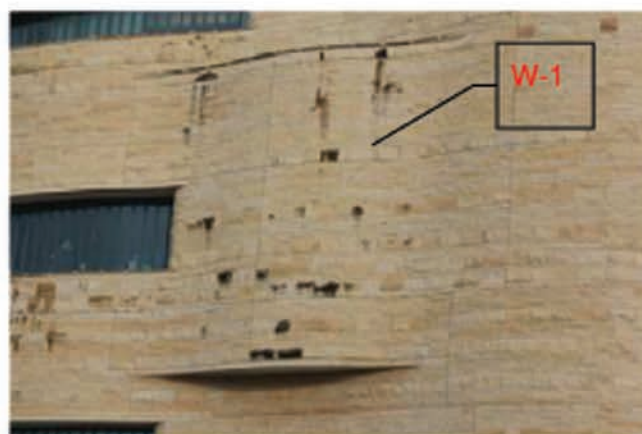
FIGURE 4. Cleaning map for the west facade. Areas W1 and W2 for cleaning are outlined in the top image. Photos by John Bixler, Smithsonian Institution.

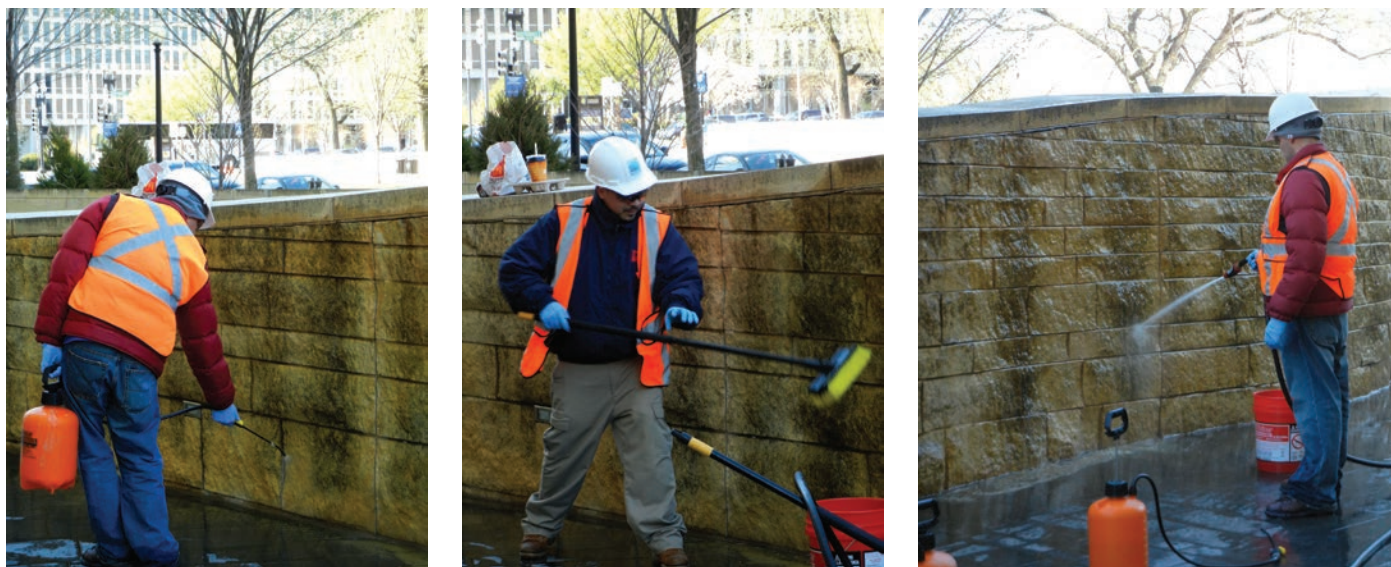
**FIGURE 5.** Application of D/2 on the loading dock wall (left), followed by scrubbing (middle) and rinsing with water (right) on April 6, 2011. Photo by Carol A. Grissom, Smithsonian Institution.

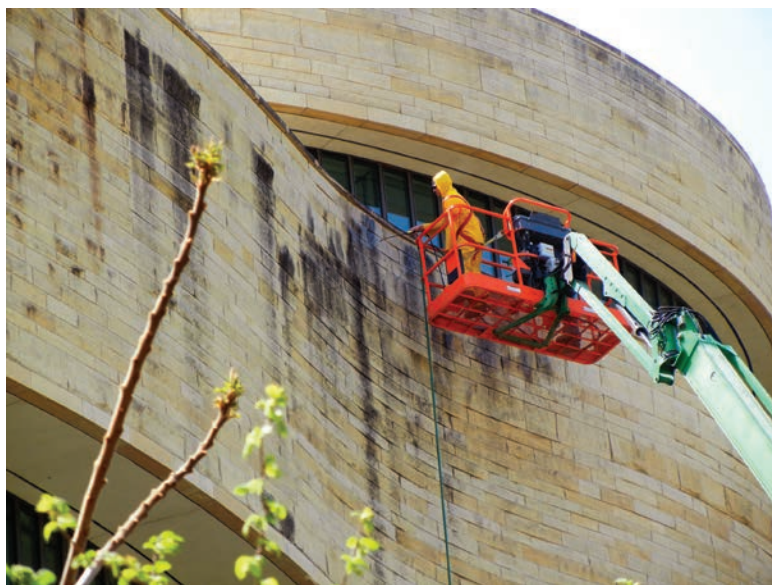
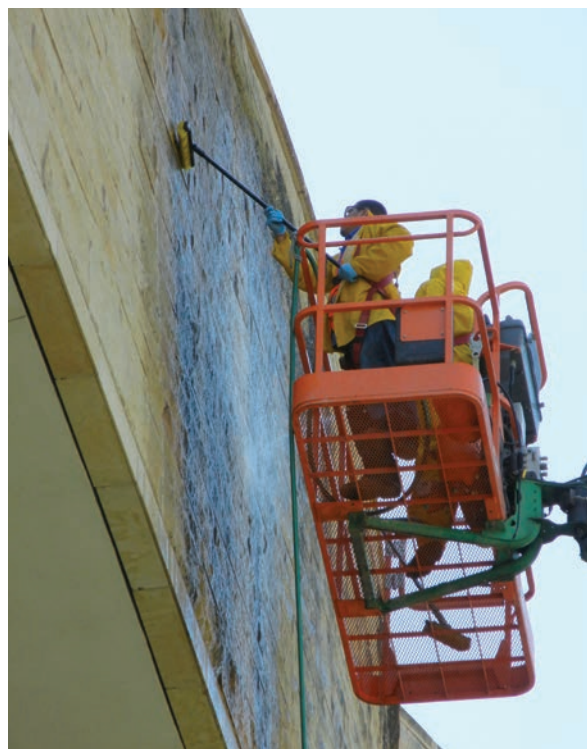
FIGURE 7. Application of the biocide D/2 to the most severely streaked area below the Inouye Terrace (left), followed by scrubbing the area (right) on April 15, 2011. Photo by Carol A. Grissom, Smithsonian Institution.

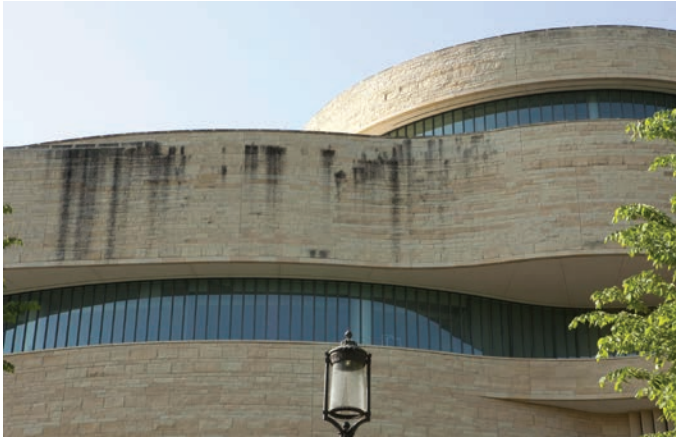
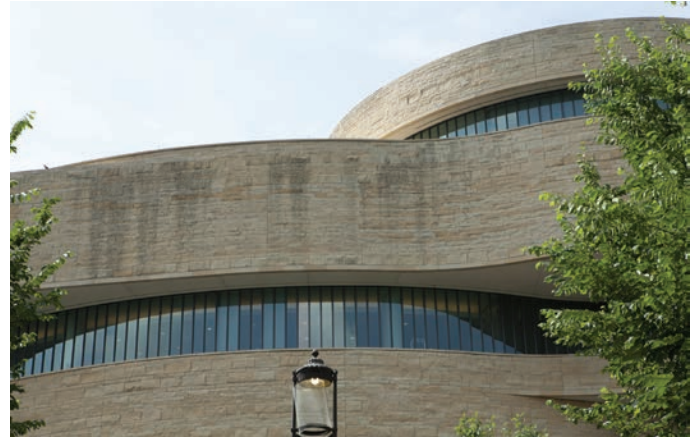
FIGURE 8. Area below the Inouye Terrace prior to cleaning in April 2010 (left) and after cleaning in May 2011 (right). Photos by Melvin J. Wachowiak, Smithsonian Institution.

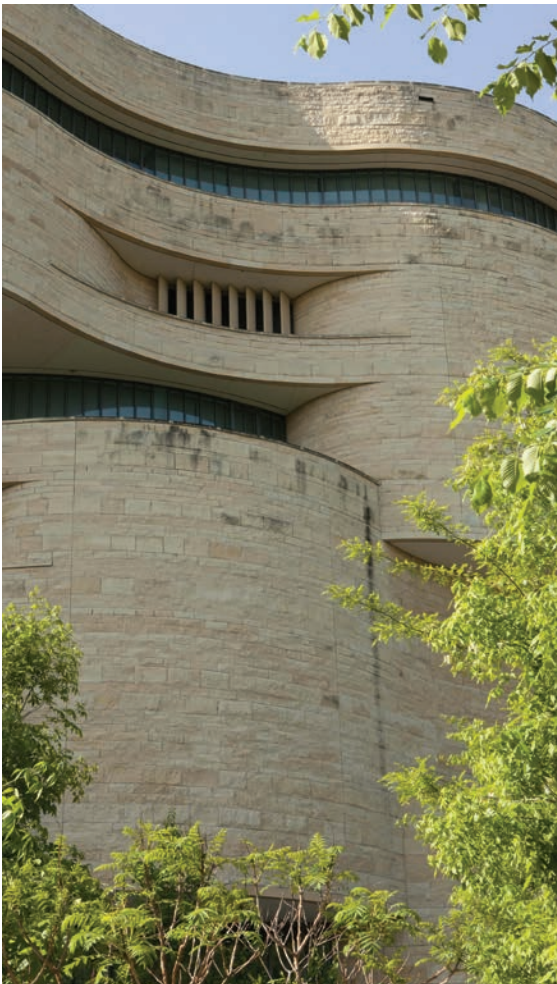
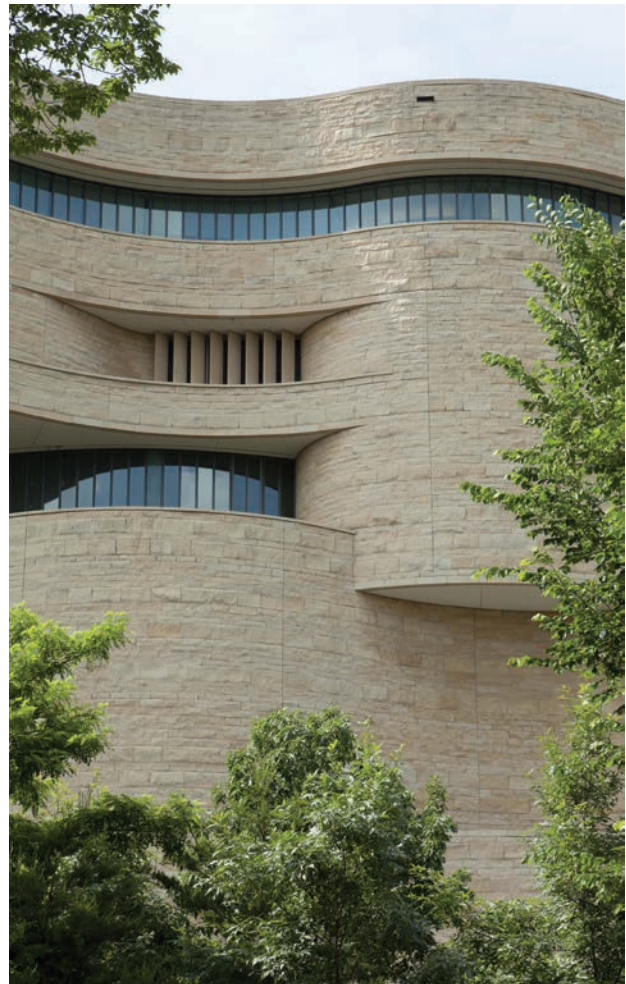
FIGURE 9. Another area on the north facade prior to cleaning in April 2010 (left) and after cleaning in May 2011 (right). Photos by Melvin J. Wachowiak, Smithsonian Institution.

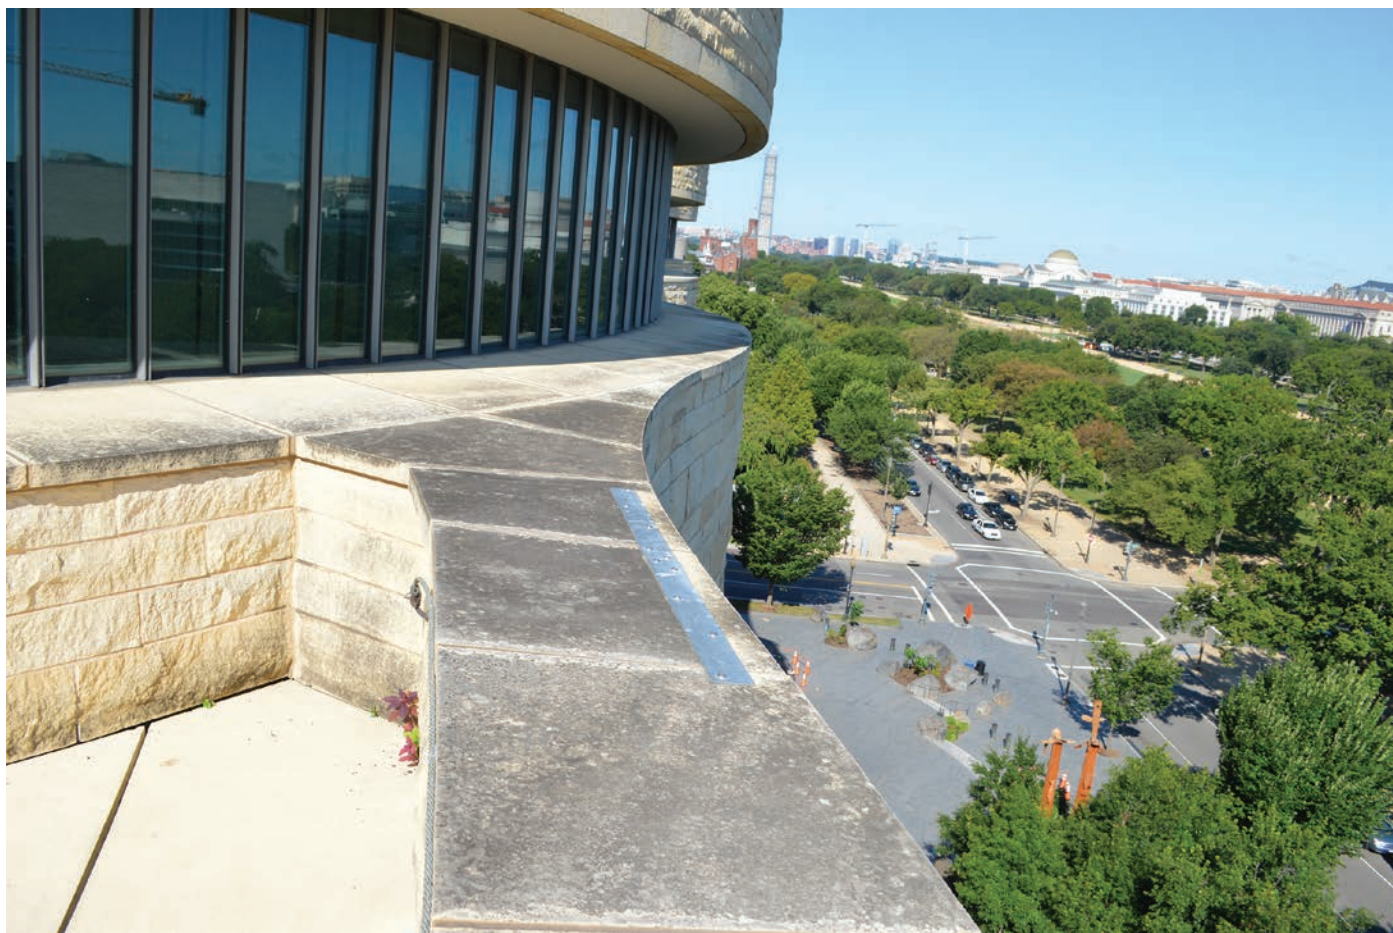
**FIGURE 11.** Second and third blocks on the Inouye Terrace, to which zinc strips have been attached, shown 18 months after installation on August 14, 2013; see figure 15 of Grissom and Charola (this volume). Photo by Carol A. Grissom, Smithsonian Institution.

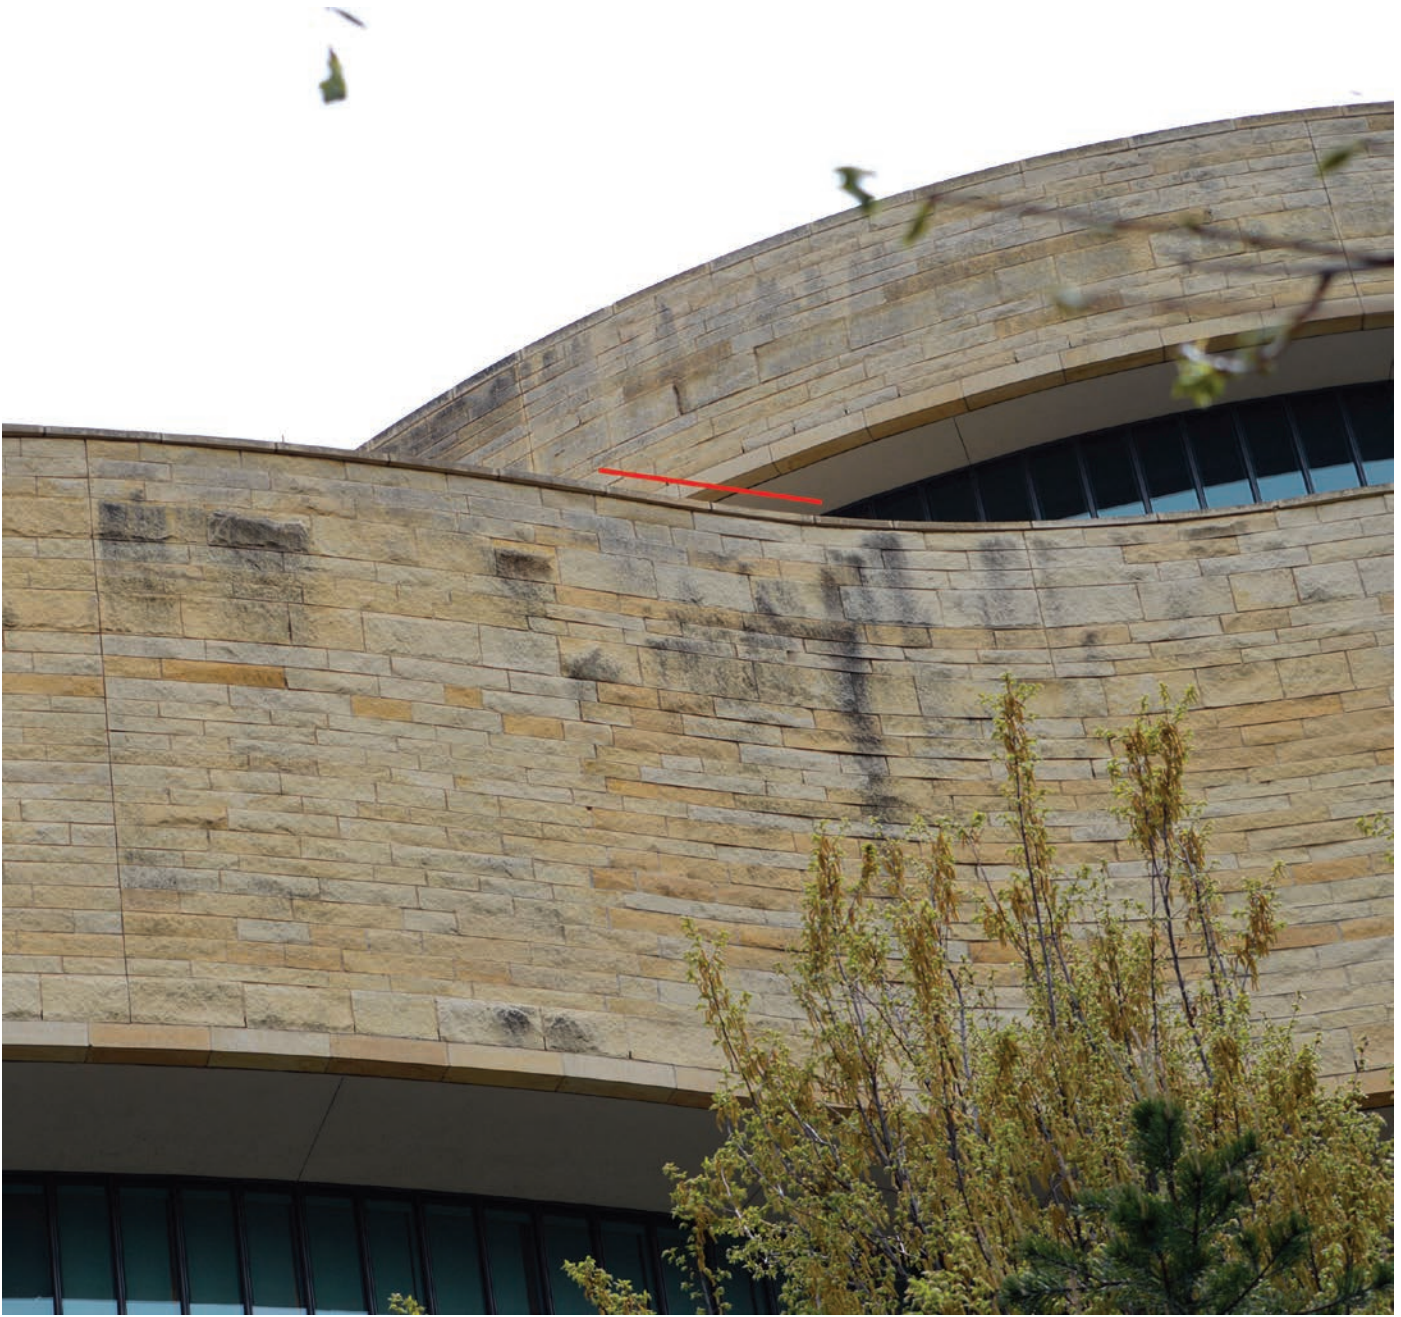
**FIGURE 12.** Detail of the facade below capstones on which zinc strips shown in Figure 11 were installed (location indicated by the red bar), eight months later (two years and two months after installation). Note that front faces of the blocks were cleaner than surrounding blocks in April 2014. Photo by Carol A. Grissom, Smithsonian Institution.
